## BS5837 2012 Tree Information – Cardiff Edge

Cardiff Edge  
Longwood Dr  
Cardiff  
CF14 7YU

James Pinder Tech Cert (Arbor A)

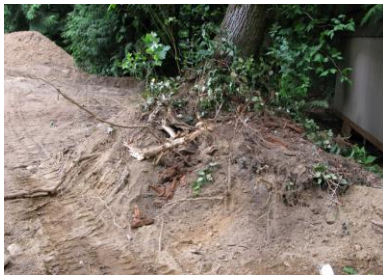
This photo shows a combination of damage. The roots have been severed or damaged in such a way that stability has been lost and this tree was felled. If the same damage had not led to an immediate tree failure the tree would have been sent into an irreversible spiral of decline.

The loss of roots will have caused a lack of structural support, loss of moisture take-up, loss of oxygen take-up and a means of the tree storing energy as starch within root structures. This type of root damage causes a slow decline in tree foliage known as crown die back.

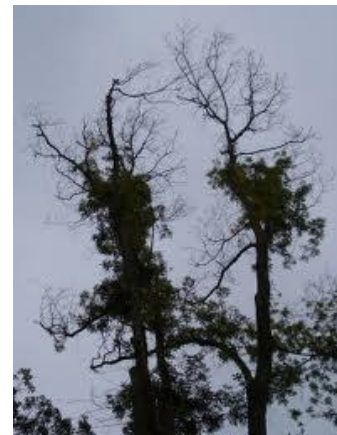
The picture to the right shows the die back of foliage several years after the completion of a development site. Machine operators will often mention how they have dug roots or driven over them. This is what happens once they leave site.

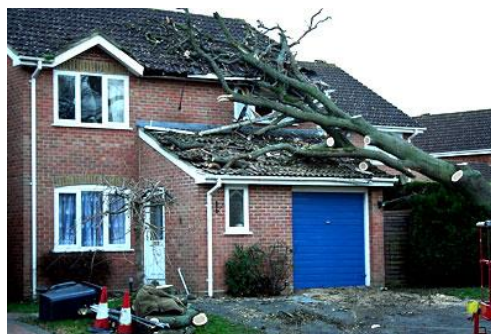
If adequate protection is not given the disaster below is not far behind!

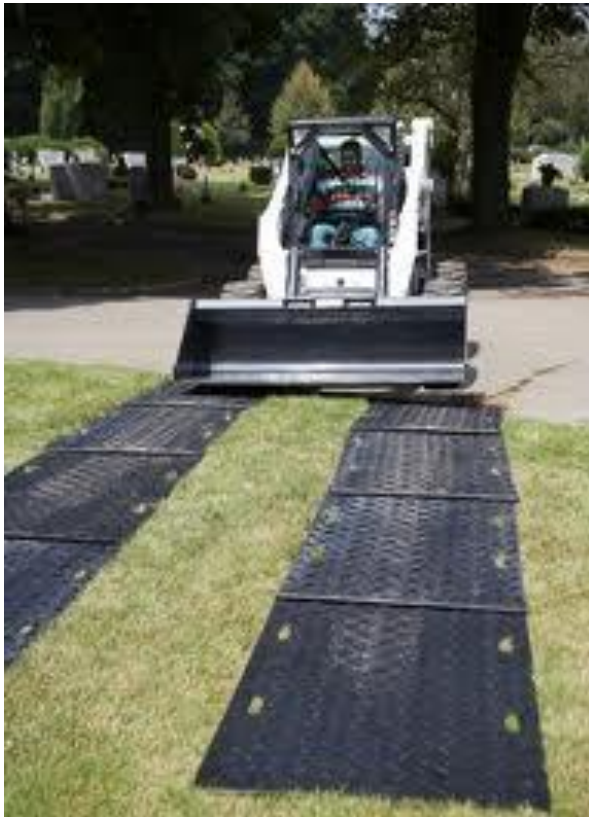
The use of ground protecting boards such as these seen in the adjacent picture should be used. Geo textile and felt may be required beneath these routes to minimize puddling of the soil surface. Should puddling occur, a capped layer may well be formed which will reduce the lateral diffusion of soil gasses and cause significant problems for retained trees.

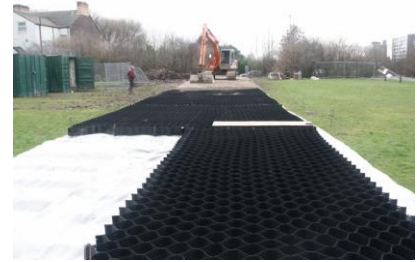
When considering possible damage to tree roots during the applications of vehicular access and parking, the risk to trees is from oxygen depletion caused by compaction of subsoils and site clearance work damaging the soil structure and roots below ground.

This damage may well lead to tree failure and can be traced back to the contractor responsible for liability claims.

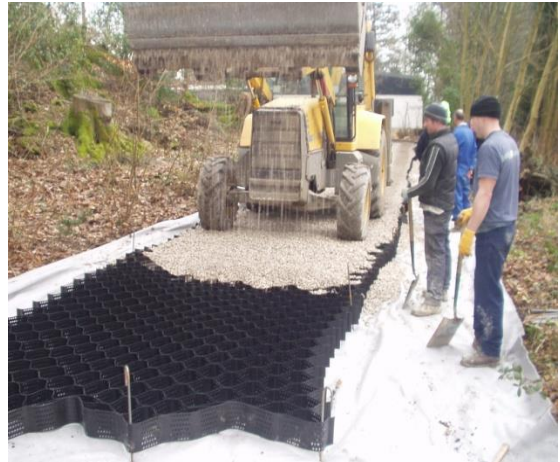
Expand the confinement systems 2.56m wide panels to the full 8.1m length. Pin the panels with staking pins to anchor open the cells and staple adjacent panels together to create a continuous mattress. Infill the cells with a no fines angular granular fill (typically 40-20mm) within each open cell. The use of cellular confinement reduces the bearing pressure on the subsoil by stabilizing aggregate surfaces against rutting under wheel loads. Comparisons between cellular confinement and traditional aggregate and geo grid-reinforced structures demonstrate a 50% reduction in construction thickness of the granular material.

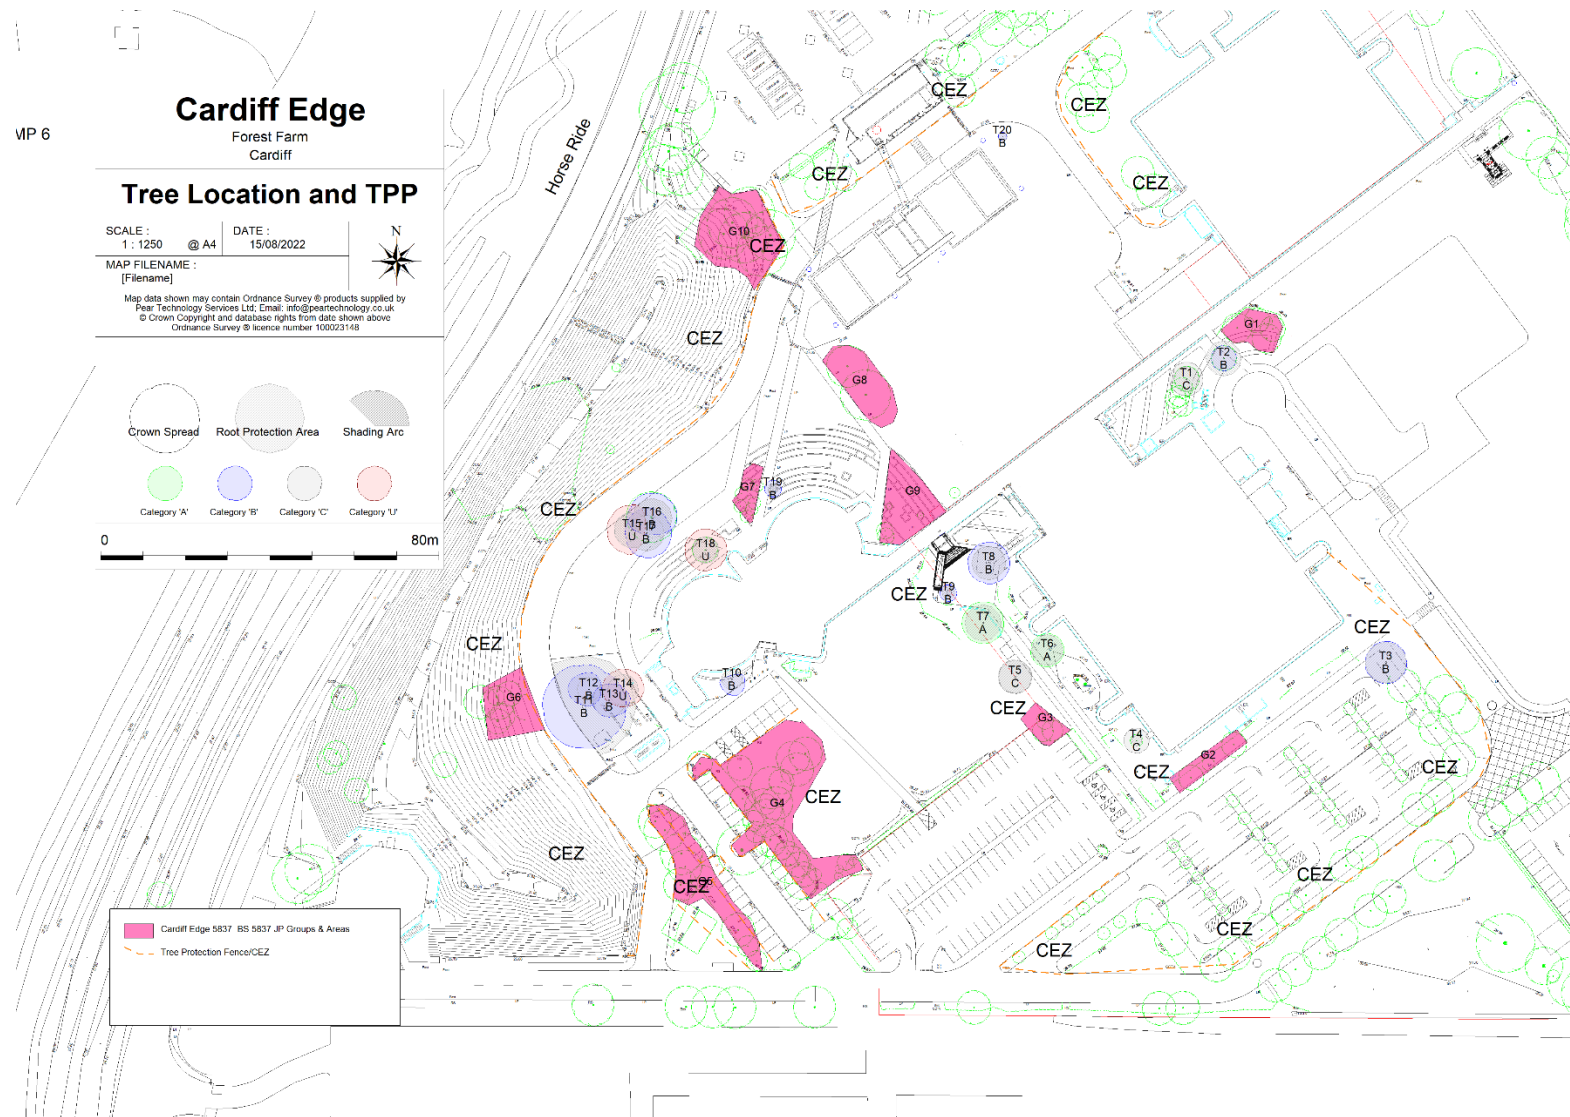
## Site Plan (Screen grab – please see scale pdf plan)

Scale plans can be sent as PDF files if required. The plans are to indicate locations of trees, locations of main objects on site and the location of tree protection fencing. Stem diameters found in tree and tree group data tables should be used to mark out the location of root protection fencing on site.

2. No mechanical plant equipment is to access retained tree RPAs areas (marked as grey hatching) as noted on the site plan at the rear of this document at any stage – ground protection must be used and advice from an arboricultural watching brief advised if roots are under access routes. The same equipment/personnel must not use the construction exclusion zones. Storage of materials is also not allowed in the CEZ or tree RPAs or in a location where run-off can enter tree occupied soils.
